HOME INSPECTION REPORT

617 Attenborough Terrace
Milton

Prepared by: Bob Papadopoulos P.Eng., RHI *

Inspection Date: July 13 2023

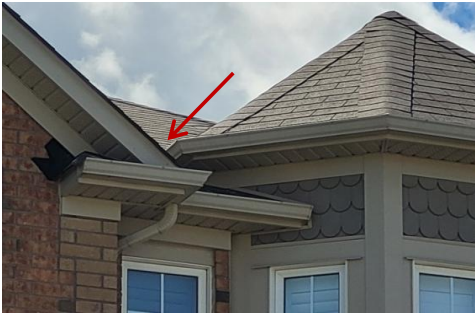
REFERENCE LINK		http://redbrickinspections.ca/docs/2_Roofing_Reference_Guide.pdf	
617 Attenborough Terrace		ROOFING/Chimneys	
		July 13 2023	
Description			
Roofing Material:	Location:	Leakage Probability:	Chimney(s) Type: Location:
Asphalt Shingles:	Slope:	Medium	
Modified Bitumen:	Flat:	Medium	deck
Asphalt Shingles:	2nd Slope:	Medium	front lower
Limitations			
Roof Inspected By:	Access Limited By:	Chimney Access Limited By:	
From Skylight			
Observations/Recommendations			
<p>Vulnerable Areas: at north west side where roof slopes converge - not unusual - presently no signs of leaking, install ice shield in this area when replacing shingles</p>

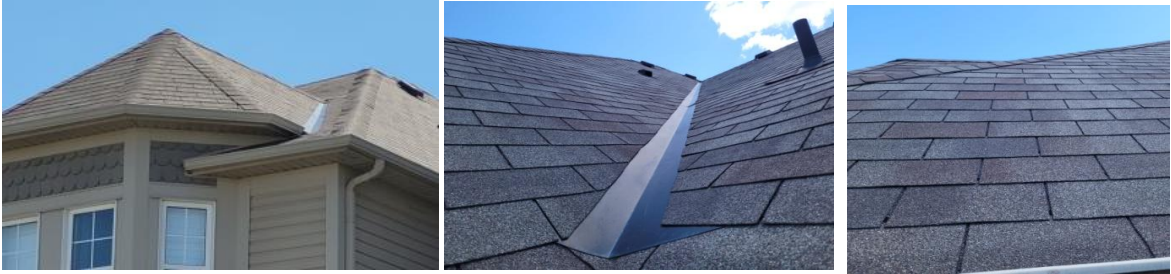
<p>Sloped Surface: overall surface in good repair lower slope at front in good repair</p>

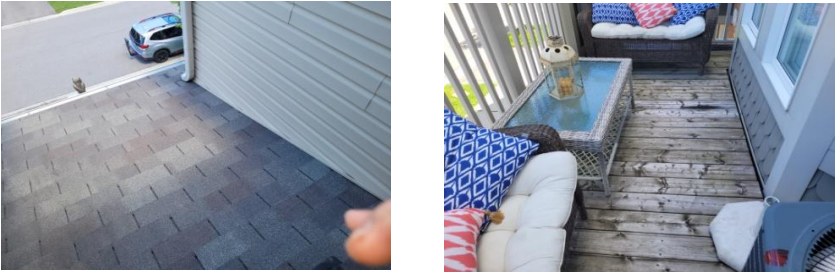
<p>2nd Flat: lower slope at front in good repair</p>			
<p>Flat Surface: deck: surface not visible due to decking, typical life expectancy is 20+ yrs</p>

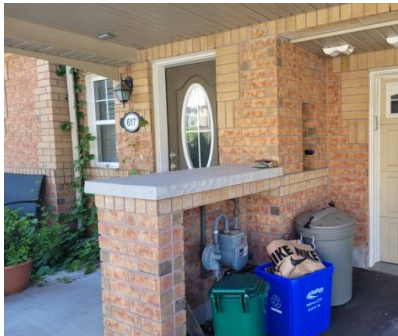
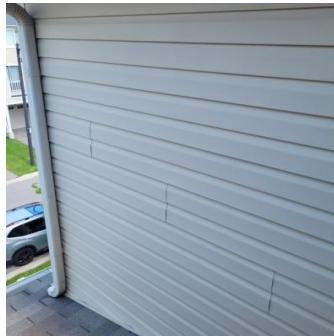
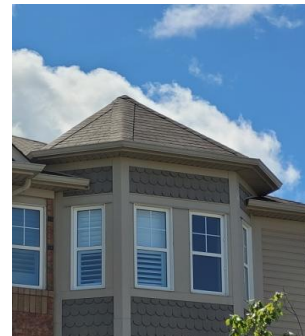
WALL SURFACES: overall in good repair
DOORS/WINDOWS: overall in good repair

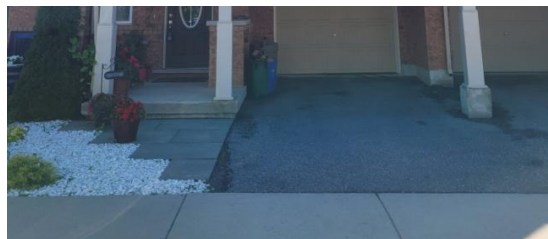
**Walk(s)/Driveway(s): overall in good repair

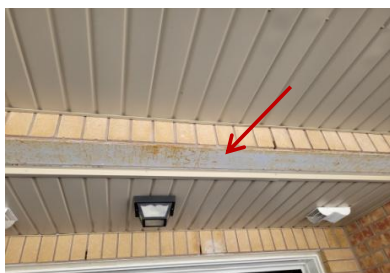
Metal Lintel: front garage - minor rust - paint

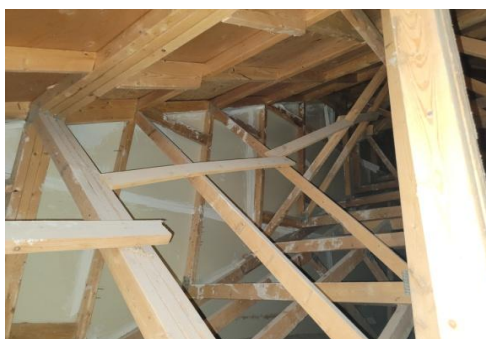
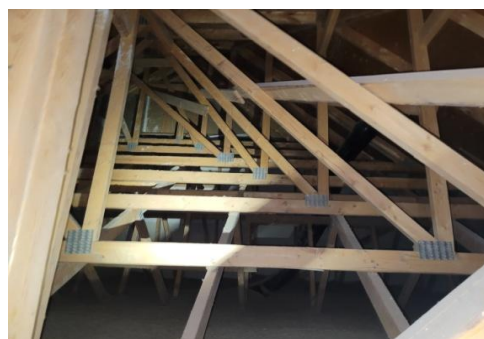
ROOF: overall in good repair

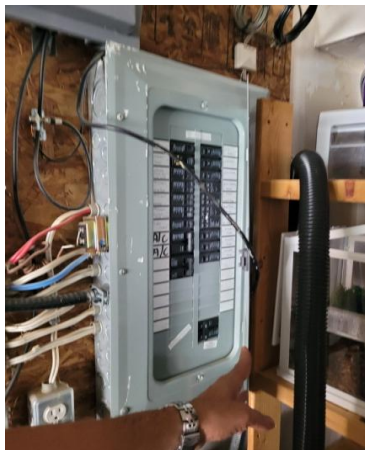
Limitations**Main Disconnect Cover Not Removed****Observations/Recommendations**SERVICE ENTRANCE: **overall in good repair**SERVICE PANEL: **overall in good repair****panel obstructed by storage - cover not removed**

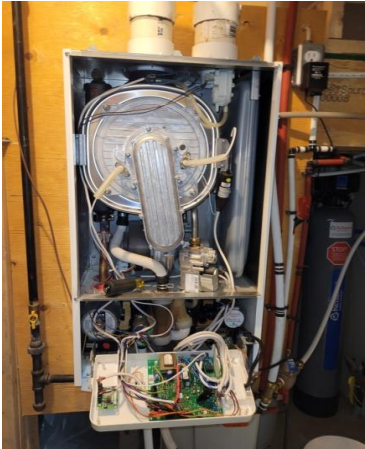
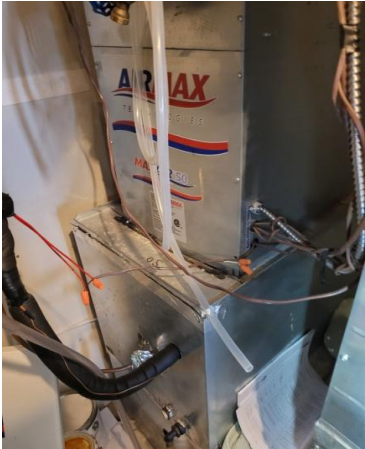
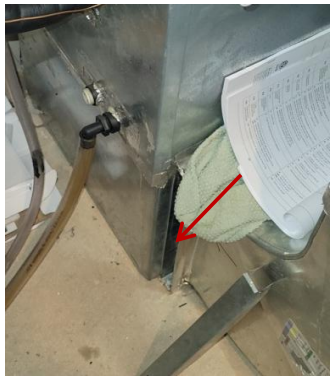
REFERENCE LINK		http://redbrickinspections.ca/docs/6_Heating_Reference_Guide.pdf				
617 Attenborough Terrace		HEATING			July 13 2023	
Description						
Description:	Efficiency:	Rated Input:	Approx. Age:	Life Expectancy:	Fuel:	Shut Off at:
Hot Water Boiler:	High	80 x1000BTU/hr	10 yrs.	15 to 20 yrs.	Gas	Meter-Exterior
Combination System:						
Electric Heater(s):						
Exhaust Vent Arrangement:		Plastic Through-Wall Vent				
Limitations						
Heat Loss Calculations Not Done						
Observations/Recommendations						
<p>HOT WATER BOILER: rented unit, recently serviced by utility</p> <p>COMBINATION SYSTEM: provides house heating and domestic hot water</p> <p>Air Handler: boiler provides hot water to heat exchanger/air handler, service annually</p> <p>Filter: replace 1-per-3 months</p>						
<div>

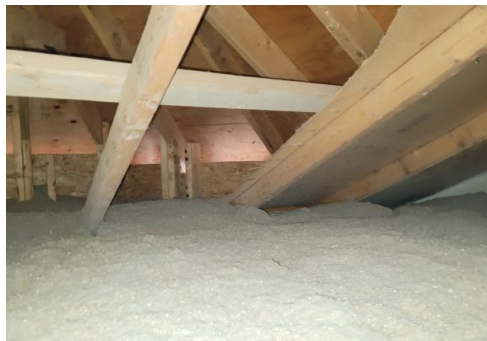
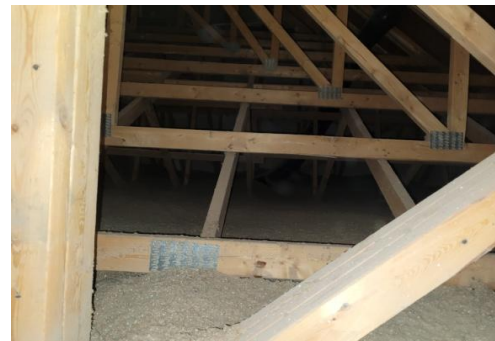
ROOF SPACE: insulation and ventilation is adequate

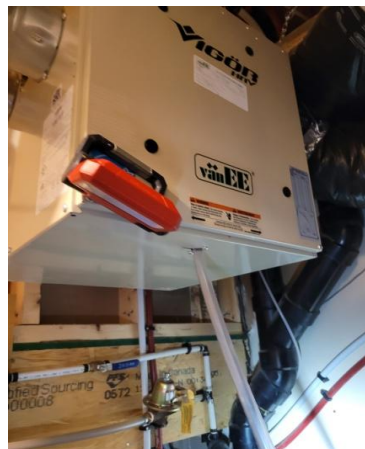
Heat Recover Ventilator: provides house with better air quality and efficiency
see owners manual for proper use and maintenance

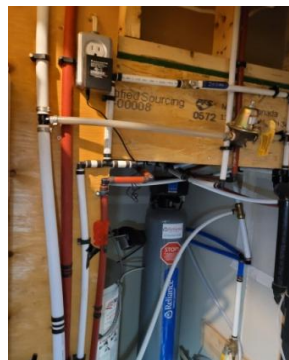
SUPPLY PIPING: [all piping examined was in good repair](#)
