# HOME INSPECTION REPORT

45 Herne Hill

Toronto

Inspection Date: May 7 2024

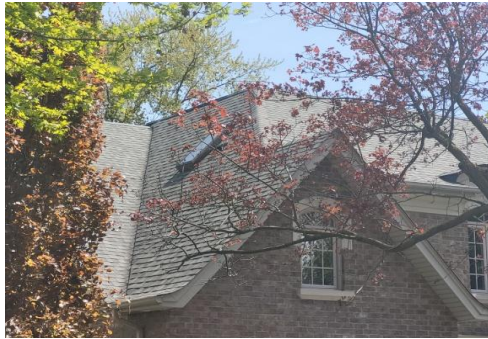
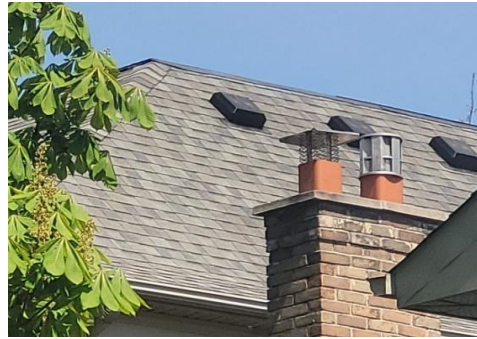
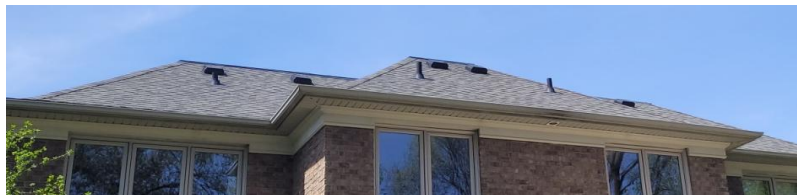
Sloped Surface: [overall surface in good repair](#)

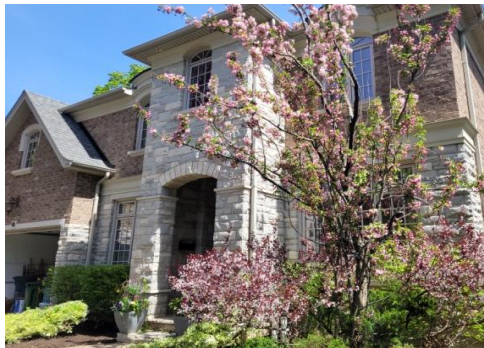
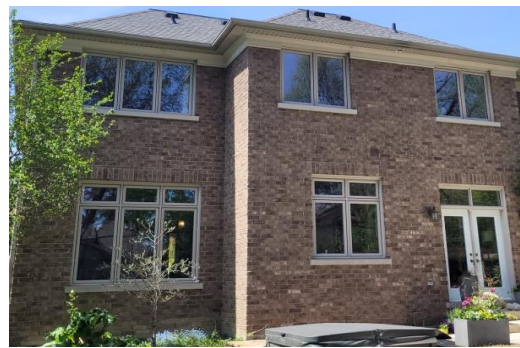
WALL SURFACES: overall in good repair  
DOORS/WINDOWS: overall in good repair  
Soffit & Facia: overall in good repair

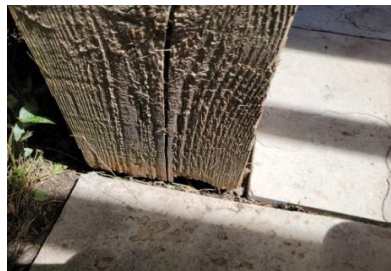
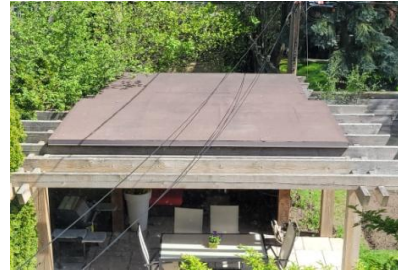
STRUCTURES gazebo: bottom of columns show some signs of rotting- monitor roof surface in good repair

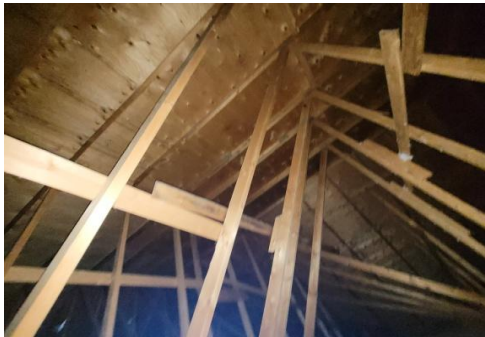
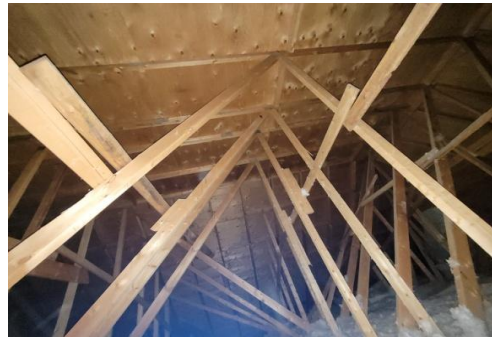
overall well built house

ROOF: overall in good repair

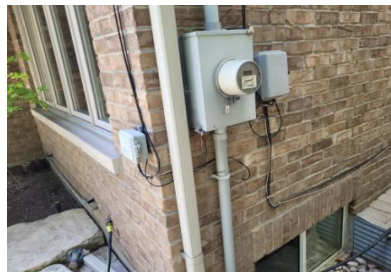
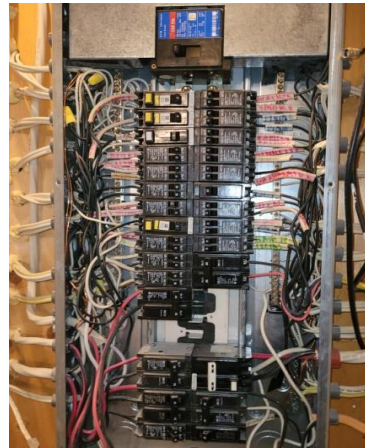
SERVICE ENTRANCE: **overall in good repair**  
 SERVICE PANEL: **overall in good repair**

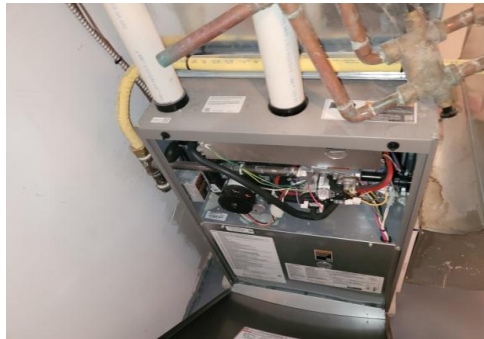
FORCED AIR FURNACE: [service annually](#)  
[recommend obtaining replacement parts contract](#)  
Filter: [replace 1-per-3 months](#)

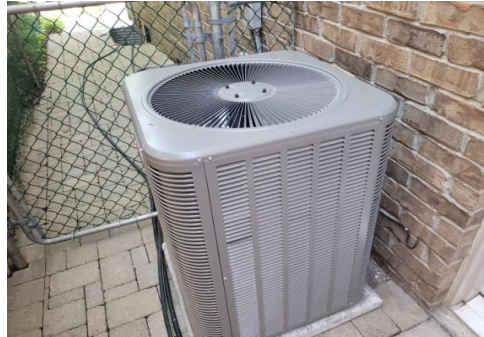
AIR CONDITIONER: not tested: should be serviced before using

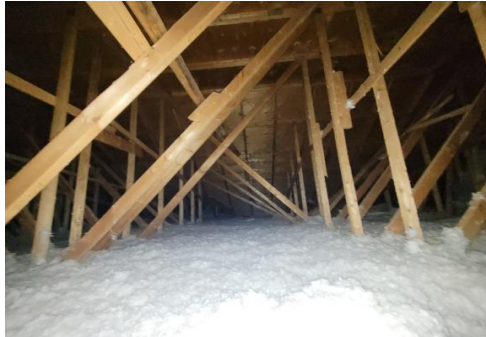
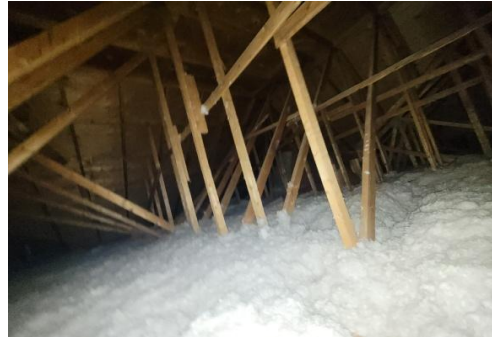
ROOF SPACE: insulation and ventilation is adequate
